Gauge Install

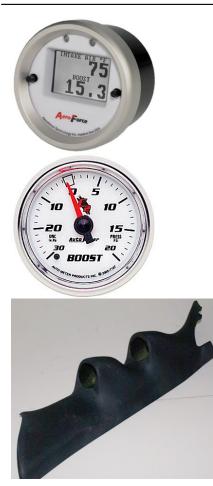
LC-1 Interceptor Autometer Boost Gauge Razor's Pillar Pod
